AVIATION SAFETY SECTION
DFS, UNHQ
2 MARCH 2012

DFS AVIATION OCCURRENCES BRIEF FEBRUARY 2012

INFORMATION BASED ON 28 PRELIMINARY AIRCRAFT OCCURRENCE REPORTS SUBMITTED DURING FEBRUARY 2012

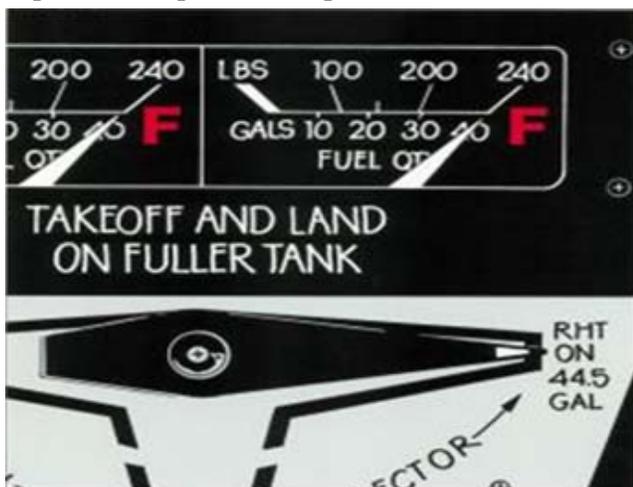
**FULL...
BUT IS IT THE
RIGHT STUFF?**

**Always conduct fuel tests
before refueling!**
