DFS AVIATION OCCURRENCES BRIEF AND 2ND QUARTER REVIEW JUNE 2012

INFORMATION BASED ON 45 PRELIMINARY AIRCRAFT OCCURRENCE REPORTS SUBMITTED DURING JUNE 2012

OR AND HR 2ND QUARTER 2012 REVIEW

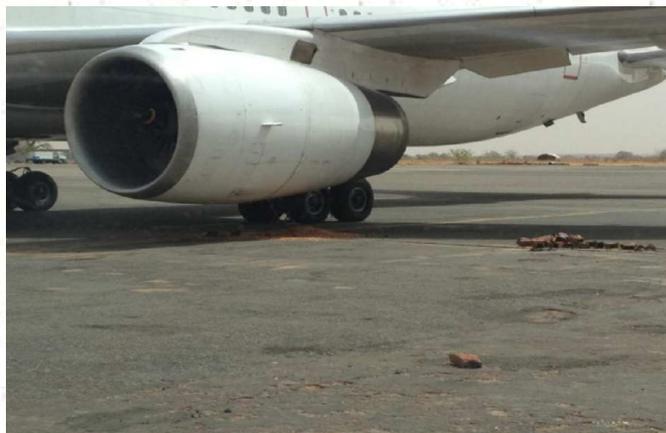
The marshaller gave parking instructions to the aircraft with left engine directly over FOD (Reported by UNAMID).

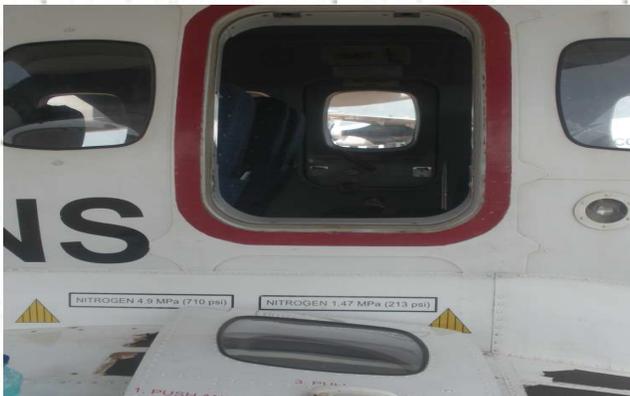
When the crew returned to the aircraft two hours later, they found the main door opened and one emergency exit removed. No property nor equipment was missing or damaged (Let 410).

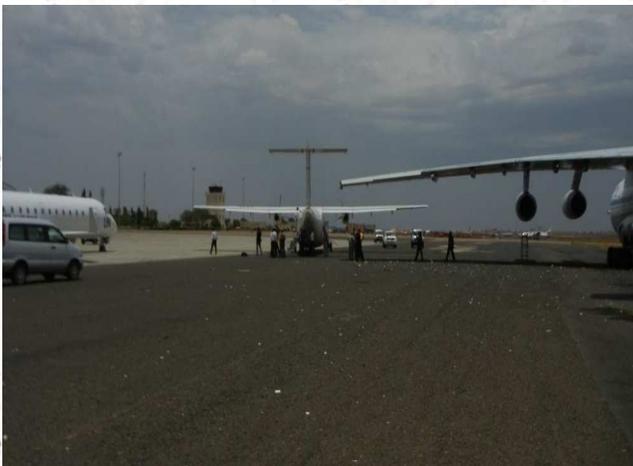
While taxiing to the runway between two parked aircraft, the right propeller stroke the left wing tip of the parked aircraft (ATR-72).

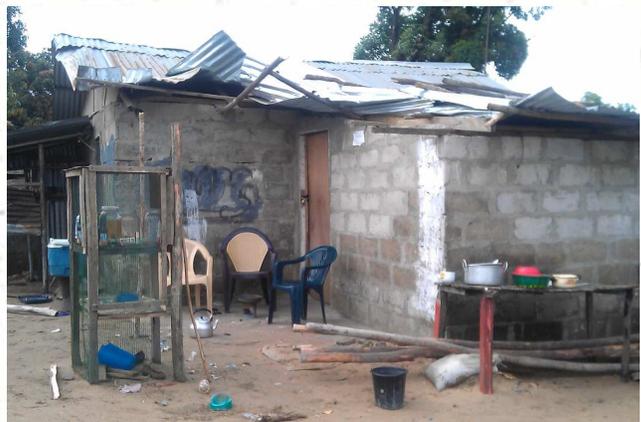
During final approach, helicopter's rotor-wash damaged the roof of a nearby house. Only material damage was reported (Mi-8 MTV).

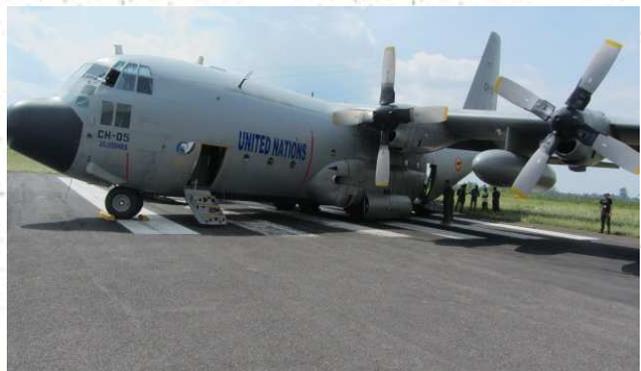
Taxiing on the runway and performing a 90° turn, the left aft main landing gear collapsed (C-130).
