DFS AVIATION OCCURRENCES BRIEF AND 3RD QUARTER REVIEW SEPTEMBER 2012

INFORMATION BASED ON 36 OCCURRENCE REPORTS SUBMITTED DURING SEPTEMBER 2012

OR AND HR 3RD 2012 REVIEW

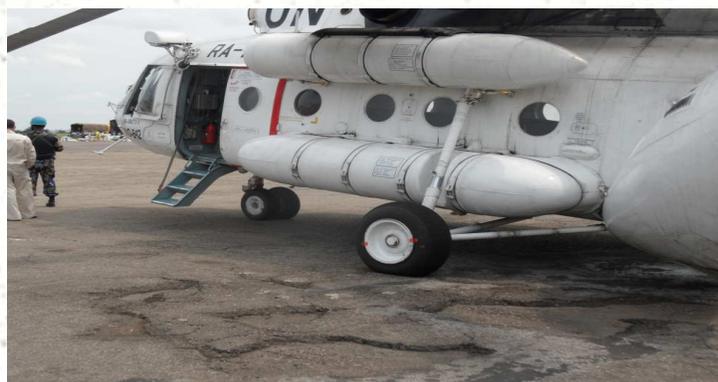
Poor condition of Tarmac is a potential risk for damage to the landing gears, propellers and a source for FOD (Reported by MONUSCO).

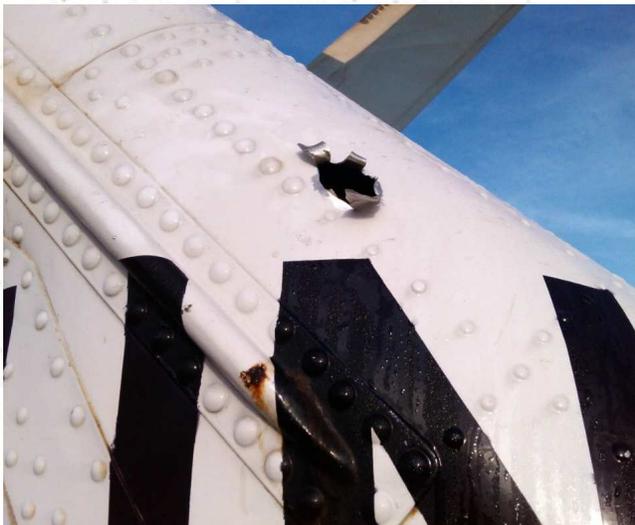
Mi-8 MTV - During the pre-flight, the crew detected a bullet hole in the rear part of the helicopter (tail rotor pylon). The crew could not determine if the damage was caused during the previous flight or while parked on the ground (*Other*).

During the pre-flight, the crew detected a bullet hole in the helicopter's vertical stabilizer (Mi-8 MTV).

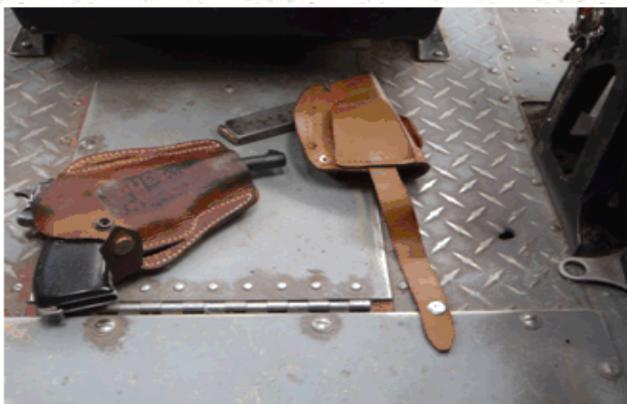
Mi-8 AMT - On the ground and while following the established procedures for loading passengers and cargo, the crew received from MOVCON two manifested firearms (pistols). After placing the weapons in the respective compartment at the crew cabin, one of the guns inadvertently discharged causing material damage to the helicopter. The flight was cancelled (*Other*).

Weapon inadvertently discharged causing material damage to the helicopter. Apparently weapon's chamber was not cleared before it was handled over to the crew (Mi-8 AMT).

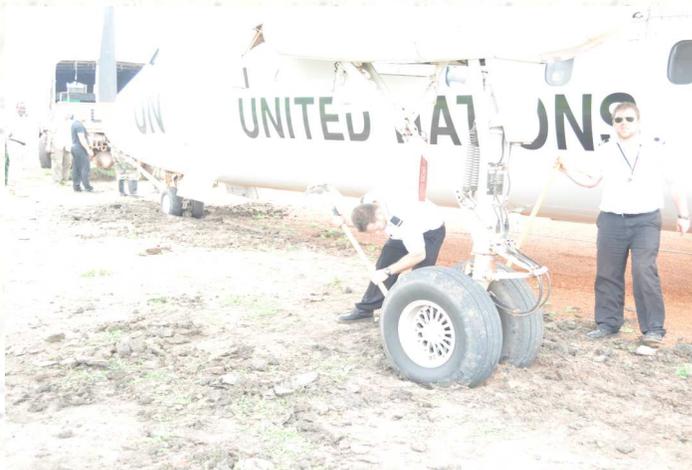
Crew was not alerted on the conditions of the airstrip and got stuck in the mud while taxiing to its parking area (DHC-7)

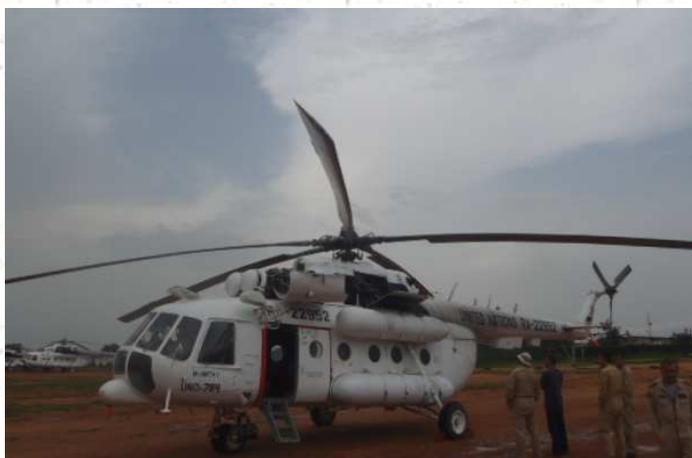
While on the ground, a rapid change in weather with wind gusts up to 50 Kts twisted one of the main rotor blades. The engines were not operating (Mi-8 MTV).
