DFS AVIATION OCCURRENCES BRIEF AND 3RD QUARTER REVIEW SEPTEMBER 2012

INFORMATION BASED ON 36 OCCURRENCE REPORTS SUBMITTED DURING SEPTEMBER 2012

OR AND HR 3RD 2012 REVIEW

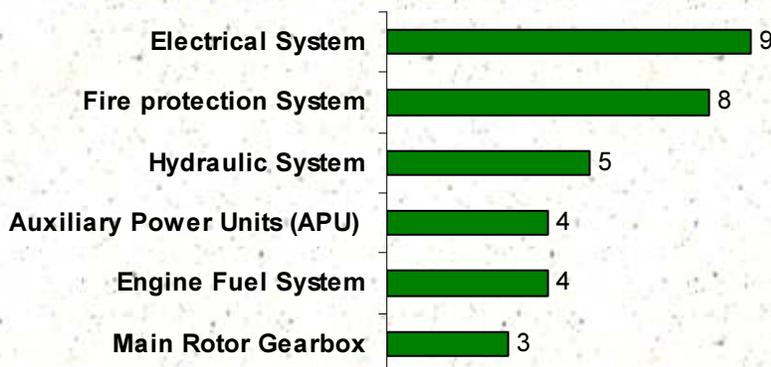
Top Technical Causes 3Q 2012

As previous Quarters, Technical occurrences are the leading nature of occurrences. Besides Power Plants in general (15), the major causes of the technical occurrences are depicted in the following chart:
